Root Cause Detection for Excess Control Rod Vibration in Fuel Injection Pump Using Shainin Methodology

Shivdarshan Sherugar^{1*}, K. Jaychandran²

²Manufacturing Process, Bosch Ltd, Bangalore, India.

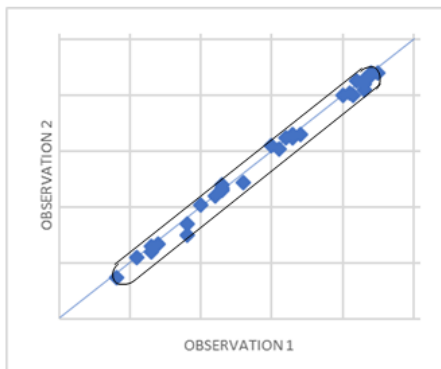
Fig. 4: Isoplot

30 pumps were calibrated on the calibration bench twice and isoplot was generated which will help in checking the variation in measurement through discrimination ratio [2]. Isoplot generated by the experimental data is shown in figure 4. As the discrimination ratio is 10.75 (more than 6.0), accuracy of the calibration bench is good. Hence, we can negate any variation in measurement.

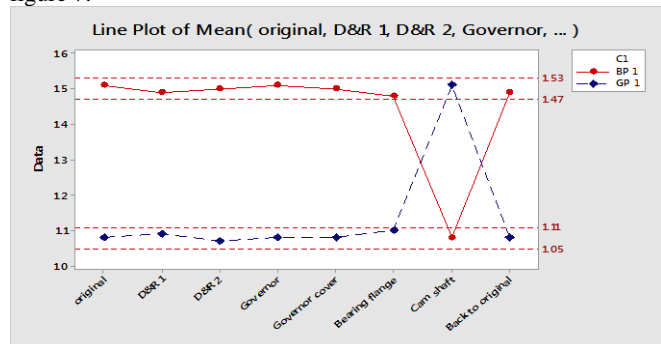
Fig. 7: Components swap results

It is clear from figure 7 that on swapping cam shaft between good and bad pump, bad pump turns to be good and good pump turns bad and same results were observed on swapping cam shaft for other two pairs which indicates the presence of Red X in cam shaft.

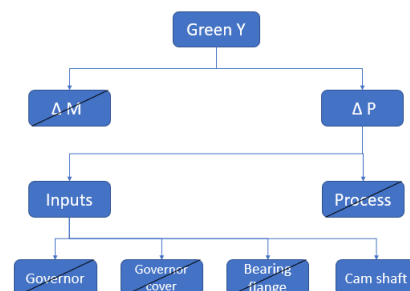
Fig. 8: Project definition tree with cam shaft as Red X component

On further analysis on cam shaft between good pump and bad pumps, it is found that the overall length of cam shaft is less than length of pump casing for all three bad pumps. The interference between cam shaft assembly and pump casing for good and bad pumps is shown in table
