Climate ‘induced’ Deterioration Aspects of Manjarabad Fort with Remedial ‘site-specific’ Restoration Measures

Abstract: *Structural Restoration of Historical Monuments is one of the key facets of Urbanization from Tourism point of view. The present study proposes a site-specific restoration methodology for “Manjarabad Fort”, a historical monument constructed during the regime of Tippu Sultan. Regrettably it is conserved very badly; in spite of A.S.I. identifying it as one of the Heritage structures. The approach followed in this case-study envisages photographic, technical, physical and historical survey. The vegetation on all the walls and grounds of the fort paraded signs of degradation necessitating immediate upkeep. The fact that the fort has its own unique architecture ethically mandates that the conservation should be prioritized without altering it. The techniques of restoration encompass clearance of vegetation about the walls, checking the physical supports for leakages and dampness; as the fort is located in a region popular for thick rainfall during monsoon. The restoration also necessitates removal of ground undulations to avoid stagnant water which may increase the da

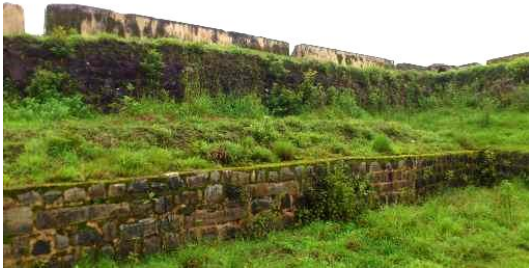
Figure 2: Vegetation growth on the Fort ground.

The major damages were introduced by accelerated unchecked growth of plants on the ground (Figure 2 and lichens on the walls (Figure 3). Primarily remedial and corrective action must engage vegetation clearance about the external surfaces (Figure 4) and on the internal surfaces (Figure 5), without damaging the structure of the fort. Also it is observed that the lichens and vegetation growths in the joints (Figure 5) of the stone masonry have created weak joints and several gaps. Also in order to retain the authenticity clay/sand mortar can be used to fill the gaps, as a mode of replacement or retouching of the missing parts.

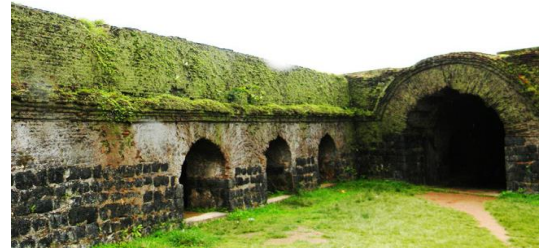
Figure 3: Vegetation growth on the wall.

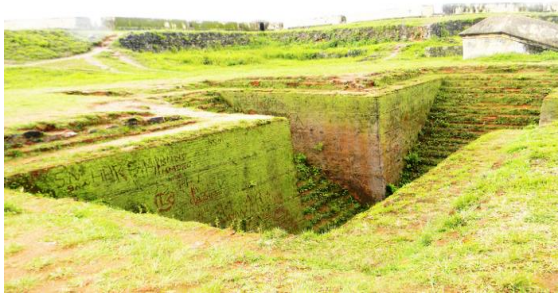
Figure 4: Vegetation on Fort's external surfaces.

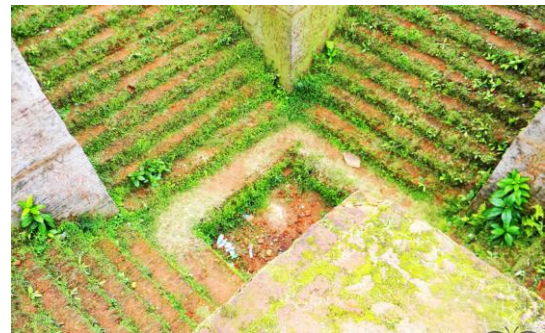
Figure 5: Vegetation on Fort's internal surfaces.

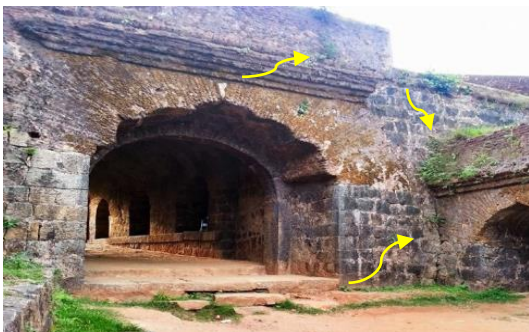
Figure 6: Vegetation growth in crevices/gaps.

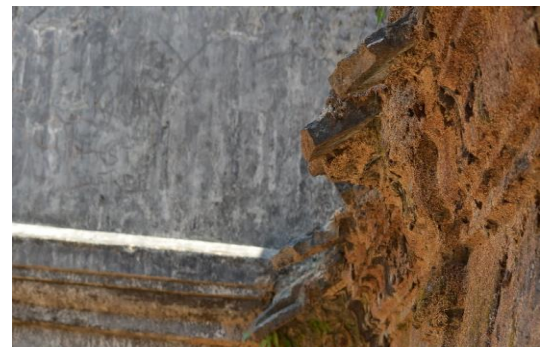
Figure 7: Weathering action by Wind.

The high velocity winds in the region have also caused the shifting and erosion of topmost layer stone of the fort walls along the wind direction (Figures 7 and 8). This can be mended if stone blocks found in fort grounds and additional blocks of the same texture are used for remaining span. In this context, sadly, most of the external and internal walls of the fort are was found to be damaged by graffiti (Figures 8 and 9). This can be addressed by gentle abrasive and heat treatment methods. At the same time, summer can aggravate natural fires due to the presence of dried vegetation about the vicinity of Fort (Figure 10) which can again tarnish the surfaces and historical engravings on the monument, hence again necessitating timely removal of weeds and vegetation.

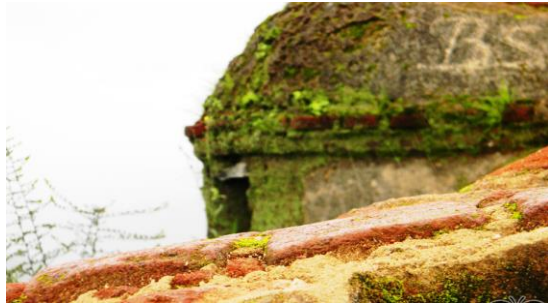
Figure 8: Damage due to Wind and Graffiti.

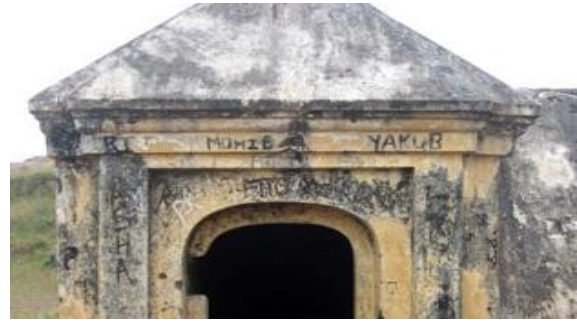
Figure 9: Graffiti and defacing of the walls.

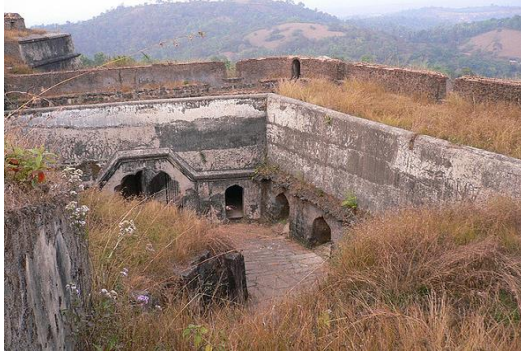
Figure 10: Dried vegetation in the vicinity of Fort.

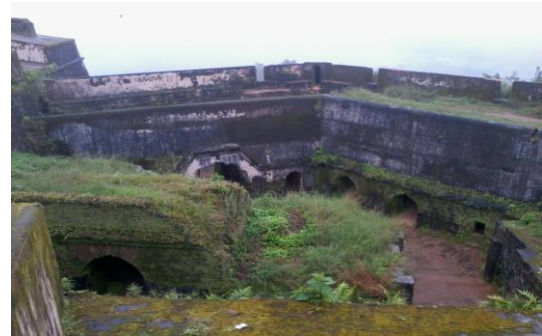
Figure 11: Dampness in the vicinity of Fort.
